# Past work on the PIMs, PIMs' crisis and PIMs Working Group

**Elias Métral**

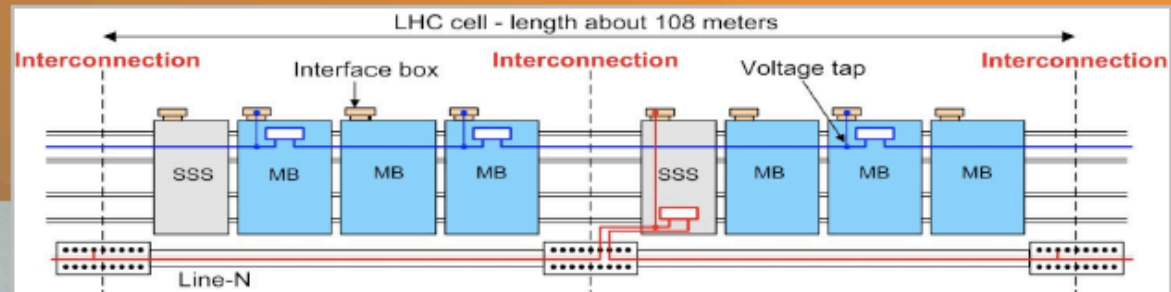
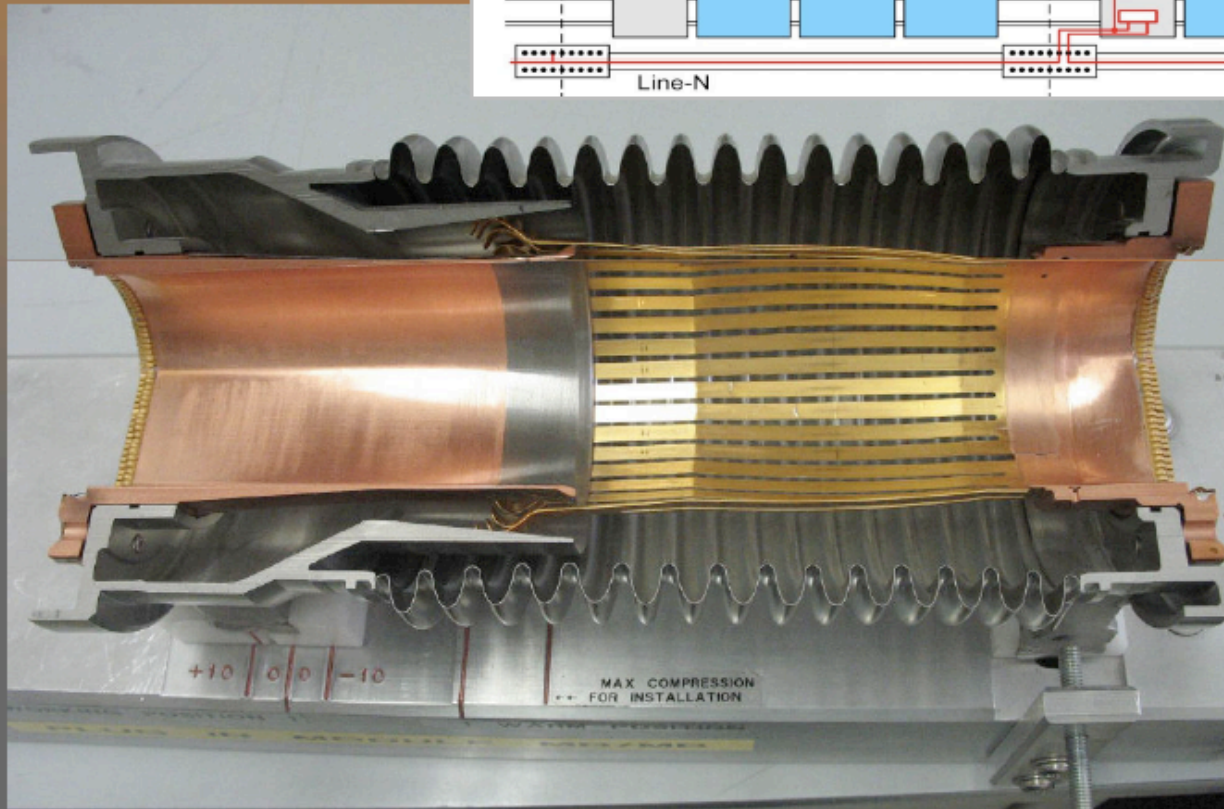
- ◆ **The 1<sup>st</sup> damaged PIM was found (by chance) around August 20<sup>th</sup>, 2007, in the sector 7-8 => Buckling**
- ◆ **1<sup>st</sup> meeting of the Working Group on August 23<sup>rd</sup>, 2007**
- ◆ **First part devoted to try and understand the exact cause(s) and to evaluate the probability of other damages**
- ◆ **In Spring 2008 the meetings resumed after the warm-up of the sector 4-5 where some damaged PIMs were also found**
- ◆ **During this period, the Working Group also worked on potential solutions to exchange a PIM without having to warm all the sector, with some tests performed at SM18**
- ◆ **The Working Group met again after the incident of the sector 3-4 in September 2008 to check if the increase of pressure in the vacuum pipe could have damaged the PIMs**

## The crisis of the PIM's

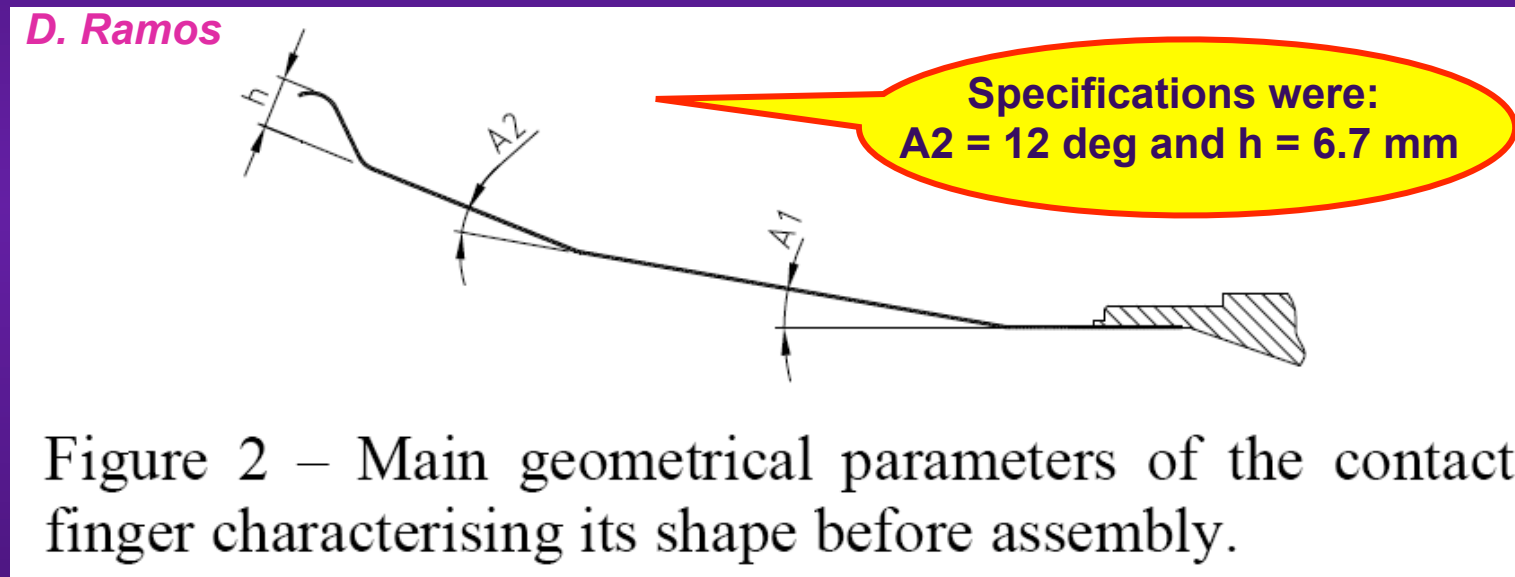
- ◆ The RF fingers have a certain number of foldings: From Modeling of the RF-shield Sliding Contact Fingers for the LHC Cryogenic Beam Vacuum Interconnects Using Implicit and Explicit Finite Element Formulations (D. Ramos, CERN-TS-2008-007, 2008)

- ◆ **To reach the specified electrical conductivity (based on DC measurements by FritzC) the angle A2 has been increased during the fabrication process at Novossibirsk (without documenting it and corrections have been done manually => different for all the RF fingers!)**

- ◆ **Conclusions:**
  - Specified DC electrical conductivity was reached for all RF fingers
  - BUT this was indentified as the cause of the buckling => Delio Ramos studied this in detail (see previous slide)

- ◆ **This issue has been fully understood:** when built within specifications the RF fingers are good but they were not built within specs... => Manufacturing issue

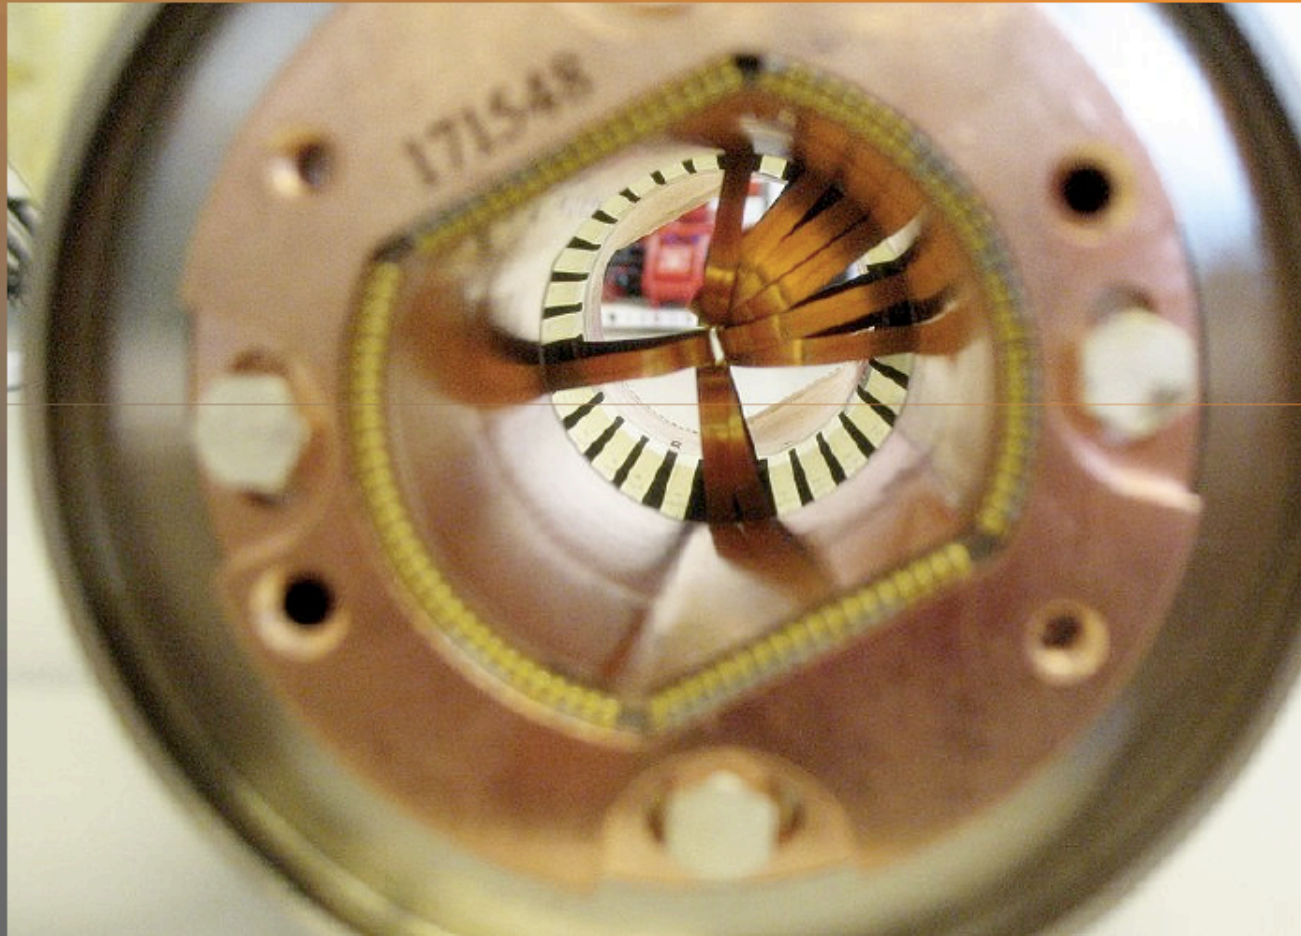
- ◆ **It was found that below a certain temperature (~ 100 K, tbc) there is no problem. But at any warm-up, buckling can be observed (even if no buckling at the previous warm-up!)**
- ◆ **Reminder:**
  - **The problem may appear during the warm-up of the adjacent magnets as in this case there is dilatation of the magnets => Contraction of the PIMs (which are between the magnets) and risk of buckling**
  - **At low temperature, the PIMs are elongated and there is no risk of buckling**

### Arc plug-in module with damaged fingers

- ◆ **Initially the idea was to change all of them, but then it was found that the most realistic/rational solutions was stay like this and change the most critical ones (~ 200 have be changed, tbc) and to test the others with the "RF or ping-pong ball" (see next slides)**

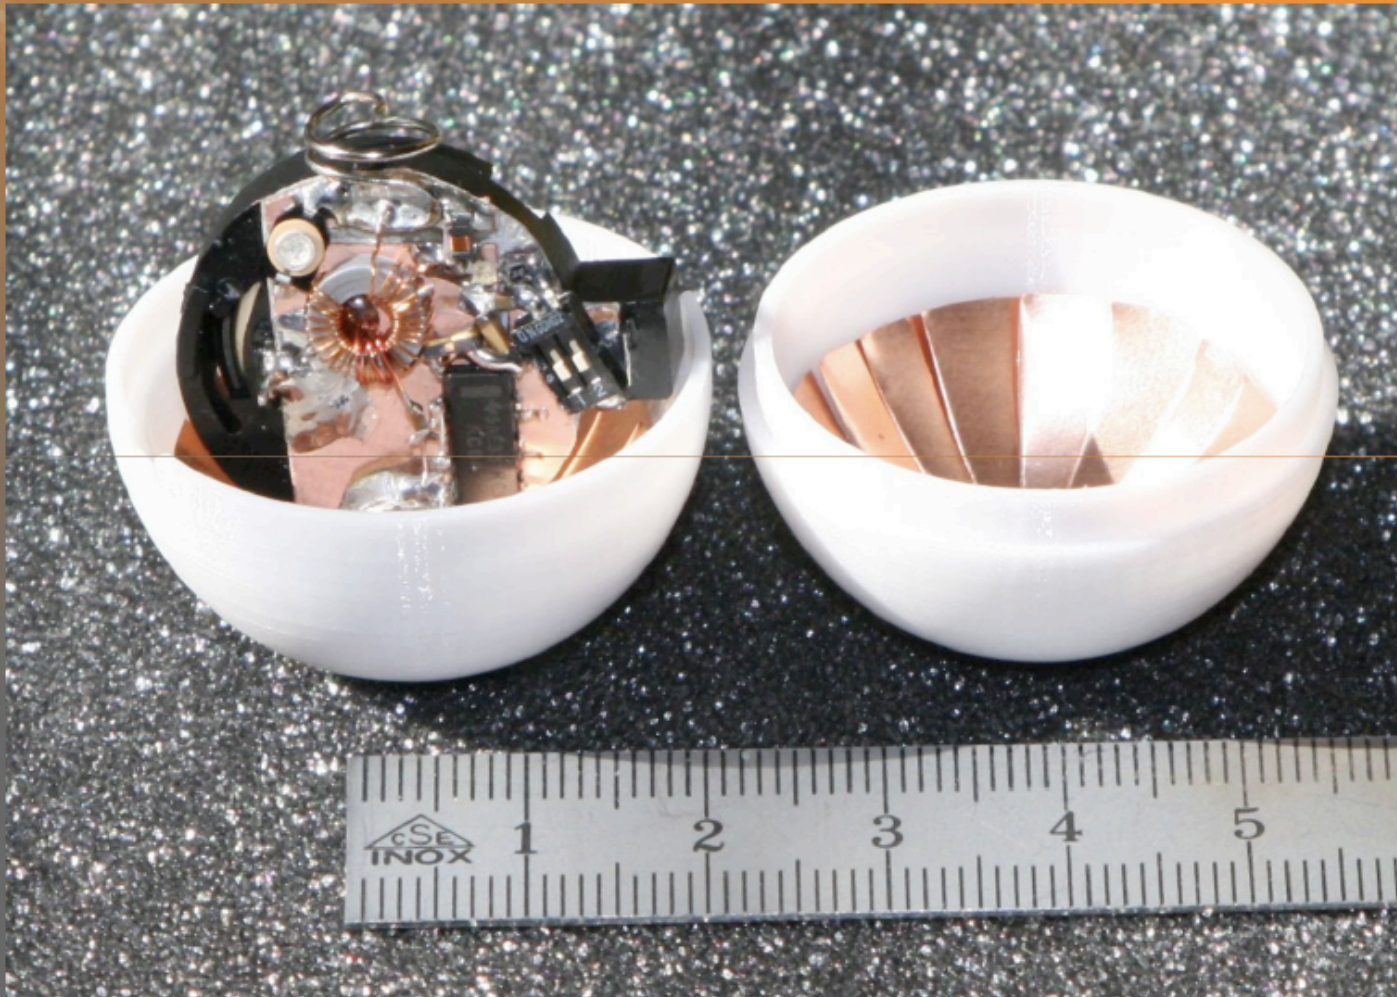
## Transmitter ball
