# LRFF (LHC RF FINGERS) TASK FORCE: Kick-off meeting!

**Elias Métral**

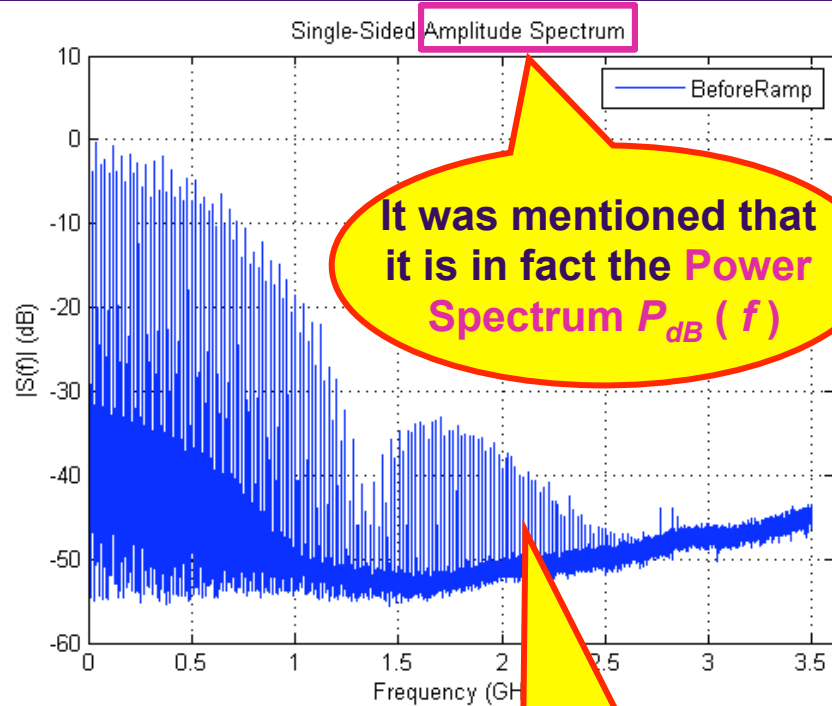
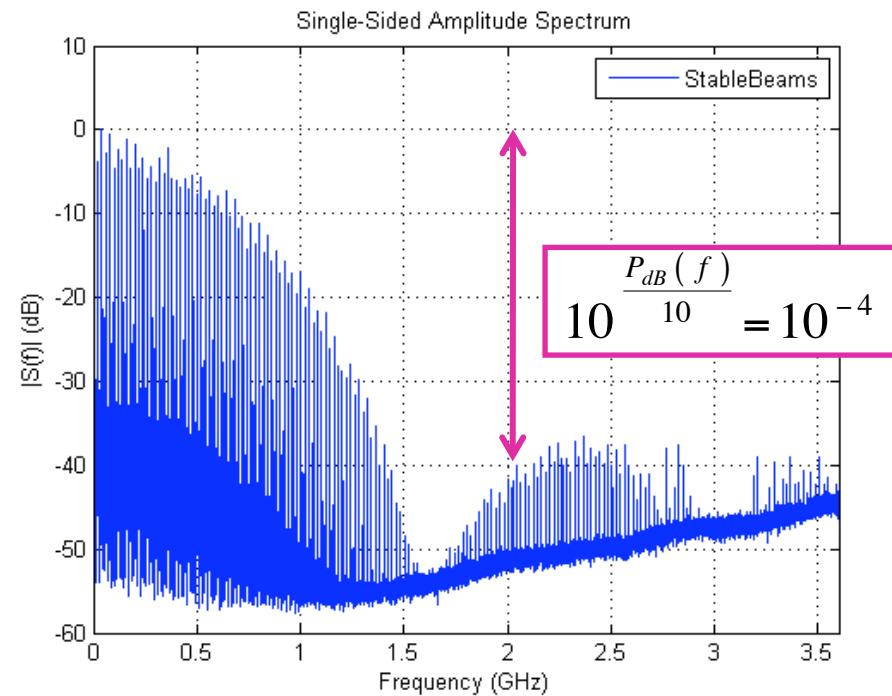
- ◆ Measurements on B1 by ThemisM and PhilippeB on fill # 2261

**Coupled-bunch lines spaced by  $M f_0 \sim 20$  MHz (for 50 ns bunch spacing) => It would be  $\sim 40$  MHz for 25 ns**

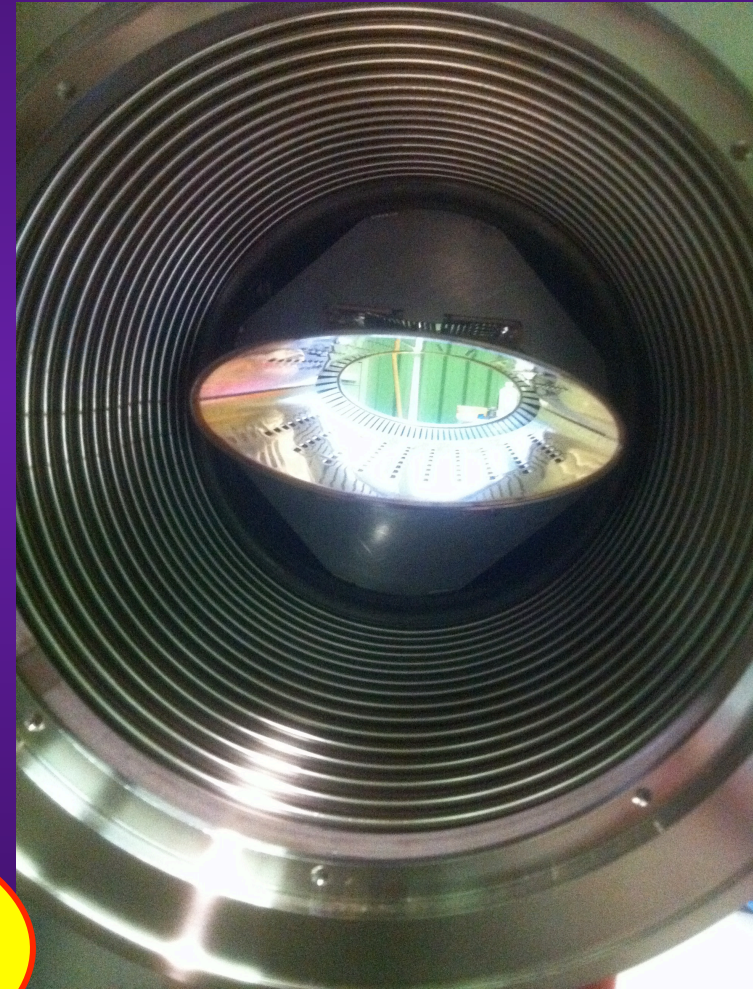
**Spring (to be put  
at the extremity of  
the RF fingers)**

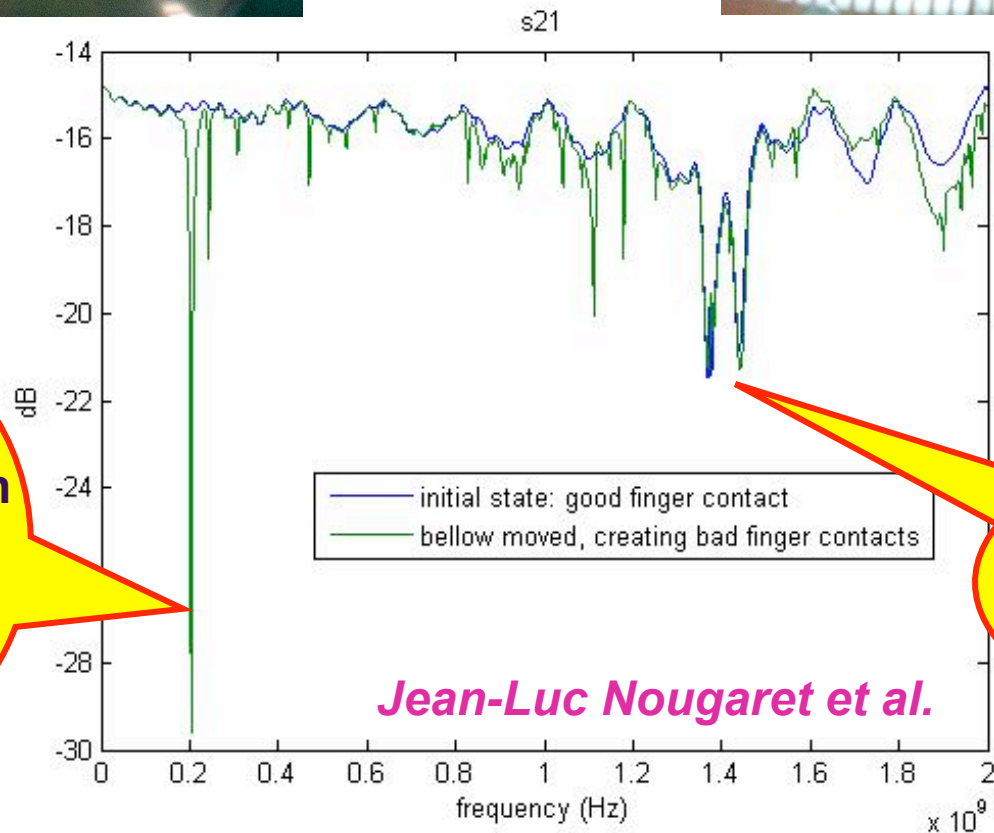
Disappear with good contact at the end plates

Huge resonance at ~ 200 MHz when the spring jumped back! => ~ -15 dB in  $S_{21}$

- ◆ Longitudinal impedance can be deduced from  $S_{21}$

$$Z_l = -2 Z_{ch} \ln\left(\frac{S_{21}}{S_{REF}}\right)$$

$$\Rightarrow Z_l = -2 Z_{ch} \ln\left(\frac{S_{21}}{S_{REF}}\right) = -2 Z_{ch} \ln\left(10^{\frac{S_{21}[\text{dB}]}{20}}\right) \approx 2 \times 270 \times \ln\left(10^{\frac{15}{20}}\right) \approx 930 \Omega$$

- ◆ **Power loss:**  $P_{loss} \sim 0.36^2 \times 930 \times 0.7 \sim 85 \text{ W}$  for 1 beam and  $\sim 4 \times 85 = 340 \text{ W}$  for 2 beams (worst case)
- ◆ **Conclusion:** No impedance problem foreseen when the RF contacts are OK => 1<sup>st</sup> recommendation: Improve the RF contacts! And add ferrite to damp some possible resonances in case of problems...

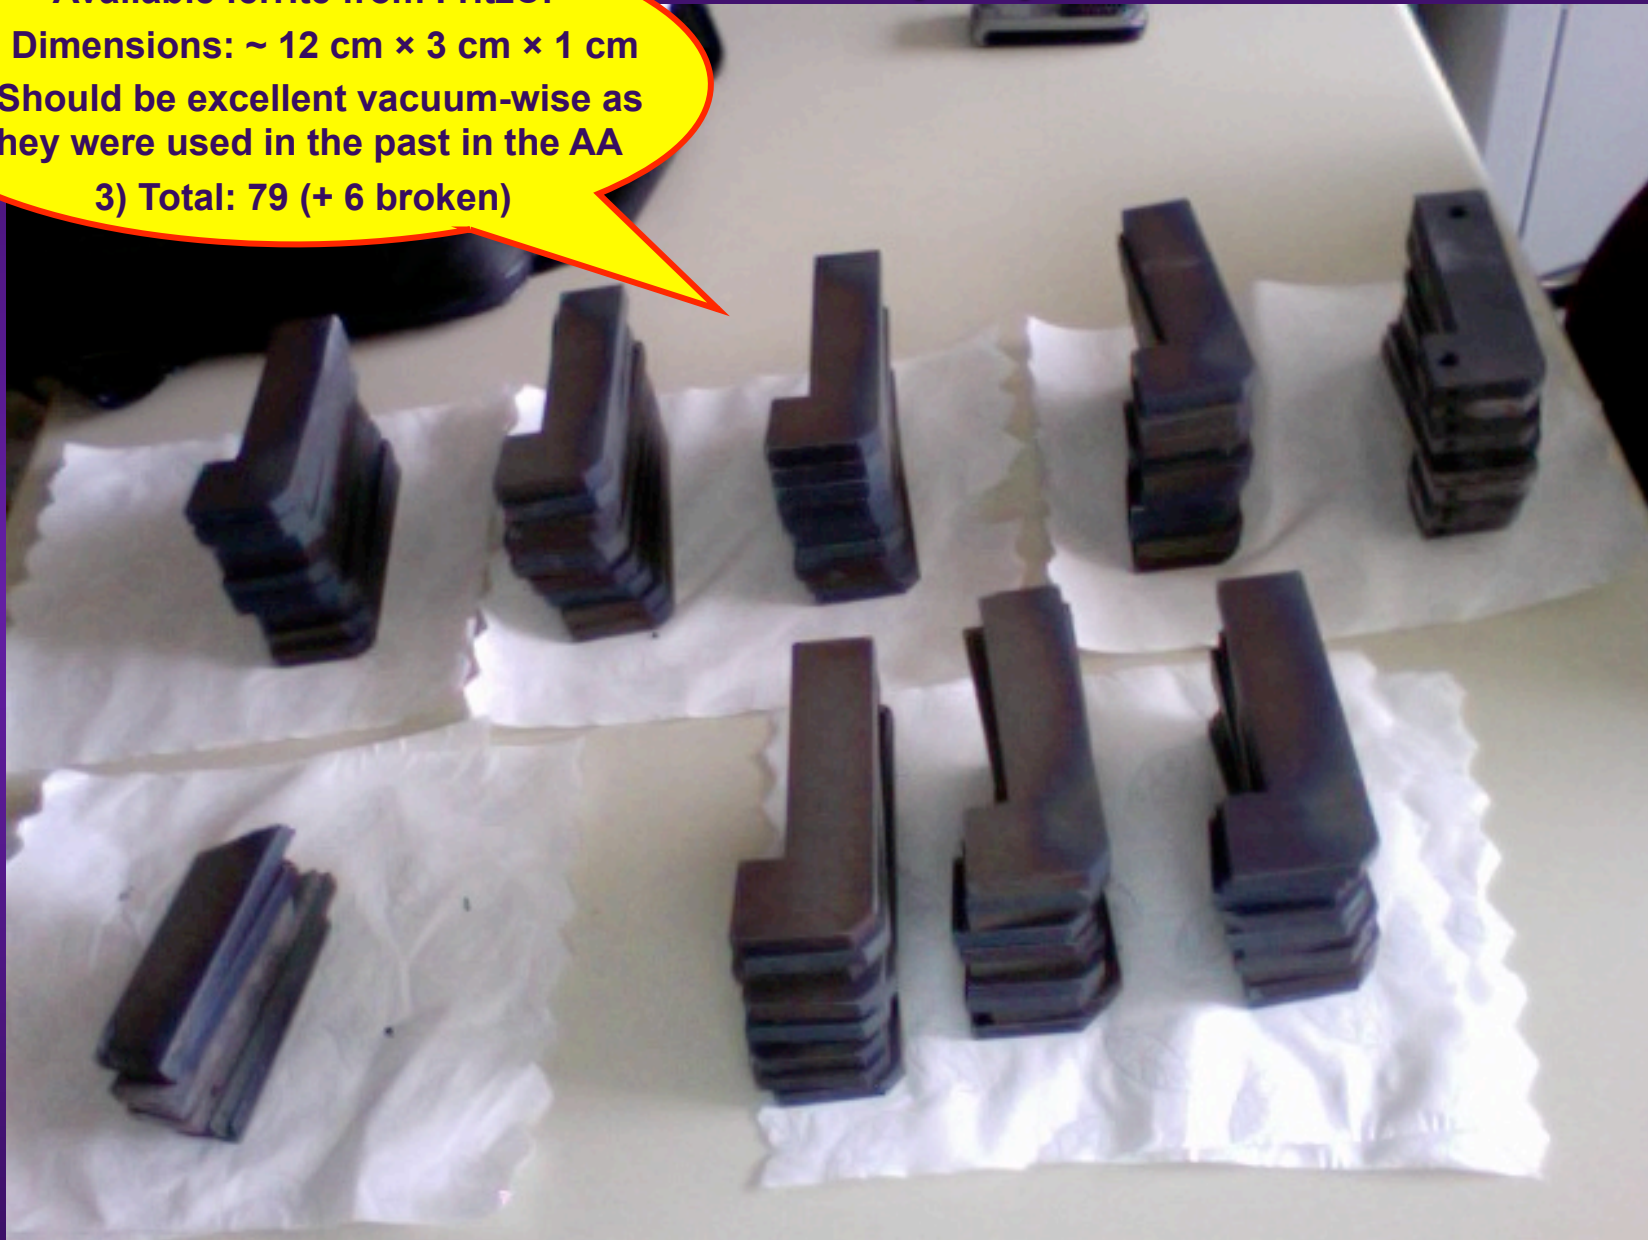
Available ferrite from FritzC:

- 1) Dimensions:  $\sim 12 \text{ cm} \times 3 \text{ cm} \times 1 \text{ cm}$
- 2) Should be excellent vacuum-wise as they were used in the past in the AA
- 3) Total: 79 (+ 6 broken)

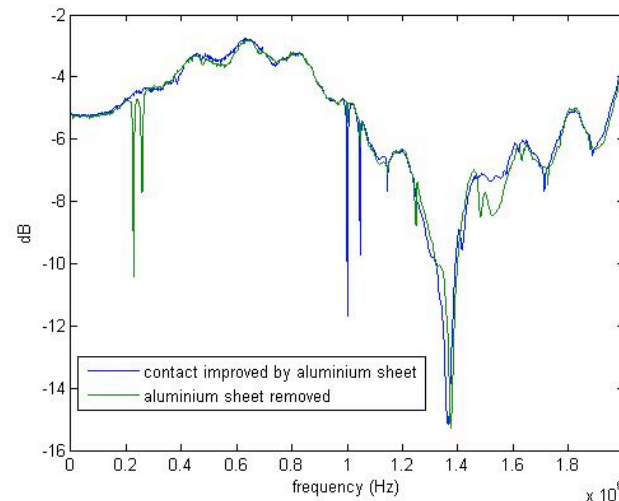
- ◆ **1<sup>st</sup> observations with a 1<sup>st</sup> version of the new VMTSA (with shorter RF fingers and ferrite plates):**
  - Close the gap otherwise the resonance at  $\sim 200$  MHz is still there!
  - Exact mechanism still to be fully understood and reproduced

Aluminium foils added (on both sides)

- No impedance problem foreseen if “good” RF contacts
- New VMTSA (with shorter RF fingers, ferrite plates and hopefully good contacts) have been installed in the LHC => Let's wait and see...
- Meanwhile we will try and fully understand the resonance at ~ 200 MHz
- What about smaller bunch lengths (probing higher frequencies)?
- What about the transverse impedances? => Requires other (longer) bench measurements and other simulations...
