# Past work on the PIMs, PIMs' crisis and PIMs Working Group

**Elias Métral**

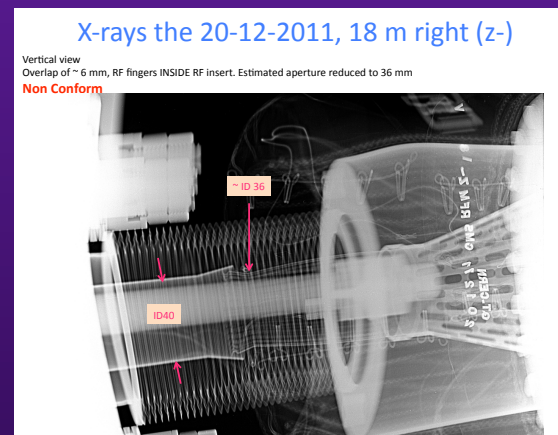
- ◆ There are ~ 1200 dipoles + ~ 500 quads => There are ~ 1700 PIMs (= Plug-In Modules) in total per turn => Detailed analysis ongoing...
- ◆ One should not mix 2 different things:
  - Incident 3-4 in September 2008 (where the PIMs were re-discussed etc.) => But it had nothing to do with the electrical and mechanical quality of the PIMs
  - The PIMs' crisis => Linked to buckling (which is not due to RF fingers falling inside due to a too long elongation etc. as could be observed for instance at 18 m right of CMS: [http://emetral.web.cern.ch/emetral/ICEsection/2011/2011-12-21/X-rays\\_CMS\\_20-12-11.ppt](http://emetral.web.cern.ch/emetral/ICEsection/2011/2011-12-21/X-rays_CMS_20-12-11.ppt))

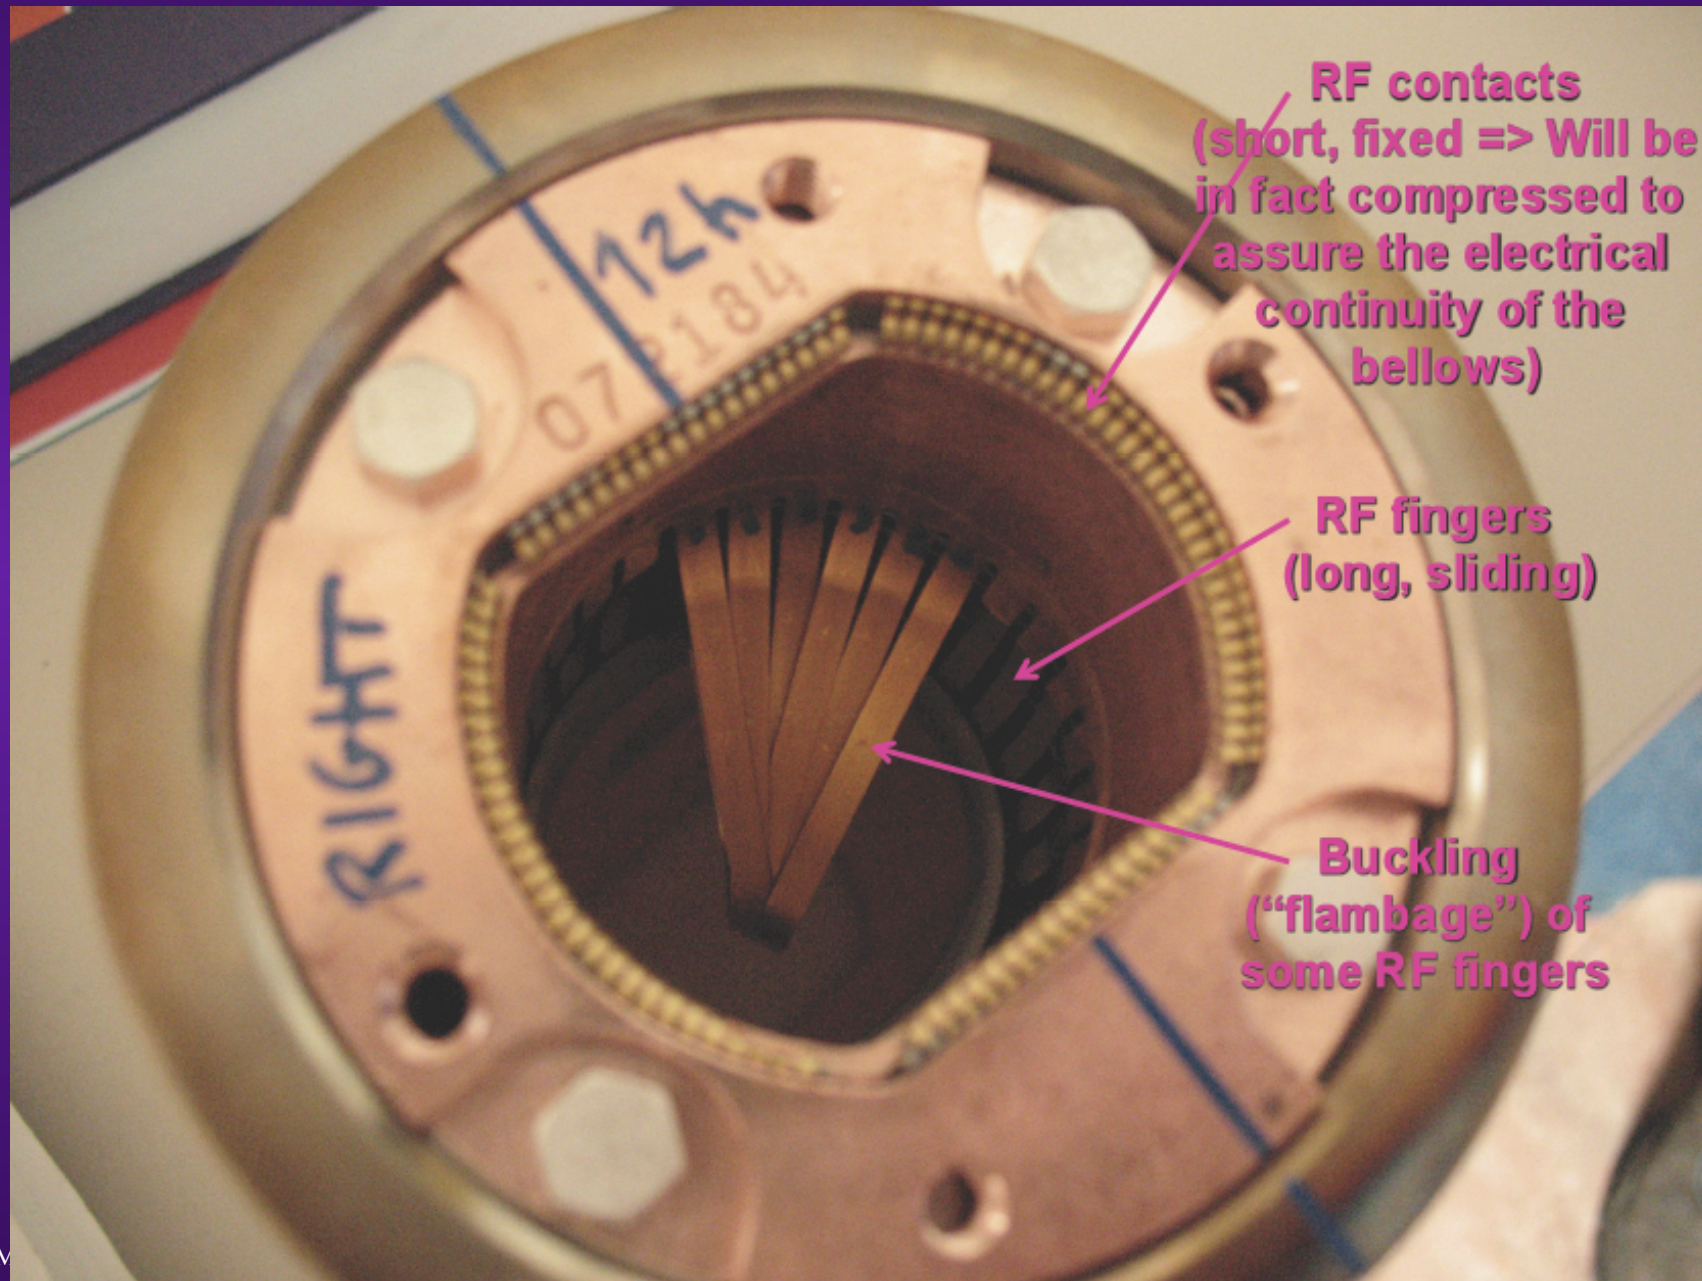
## PIMs' crisis and PIMs' Working Group (10/10)

- ◆ **Reminder of discussion with Francesco Bertinelli (22/09/2010) => See [https://impedance.web.cern.ch/impedance/LHC/PIM/DiscussionOnLHCPIMs\\_FrancescoBertinelli\\_22-09-10.pdf](https://impedance.web.cern.ch/impedance/LHC/PIM/DiscussionOnLHCPIMs_FrancescoBertinelli_22-09-10.pdf) :**
  - This buckling was discovered in the past by chance, always at the same places (revealing a type of PIM) and it was understood that this issue came from a manufacturing problem
  - Solution proposed => Displace all the SSS by 2 mm. This was done and it reduced considerably the number of bucklings of RF fingers
  - Now, if we warm up a sector, the latter is then tested with the RF ball (ping-pong ball) => This is an additional constraint for the cryo: it needs to remain below ~ 80-100 K (above these temperatures we introduce some plastic deformations)
